NRL Report 6293
AFML-TR-64-408

Electron Microscope Fracture Examination to Characterize and Identify Modes of Fracture

C. D. BEACHEM

*Physical Metallurgy Branch
Metallurgy Division*

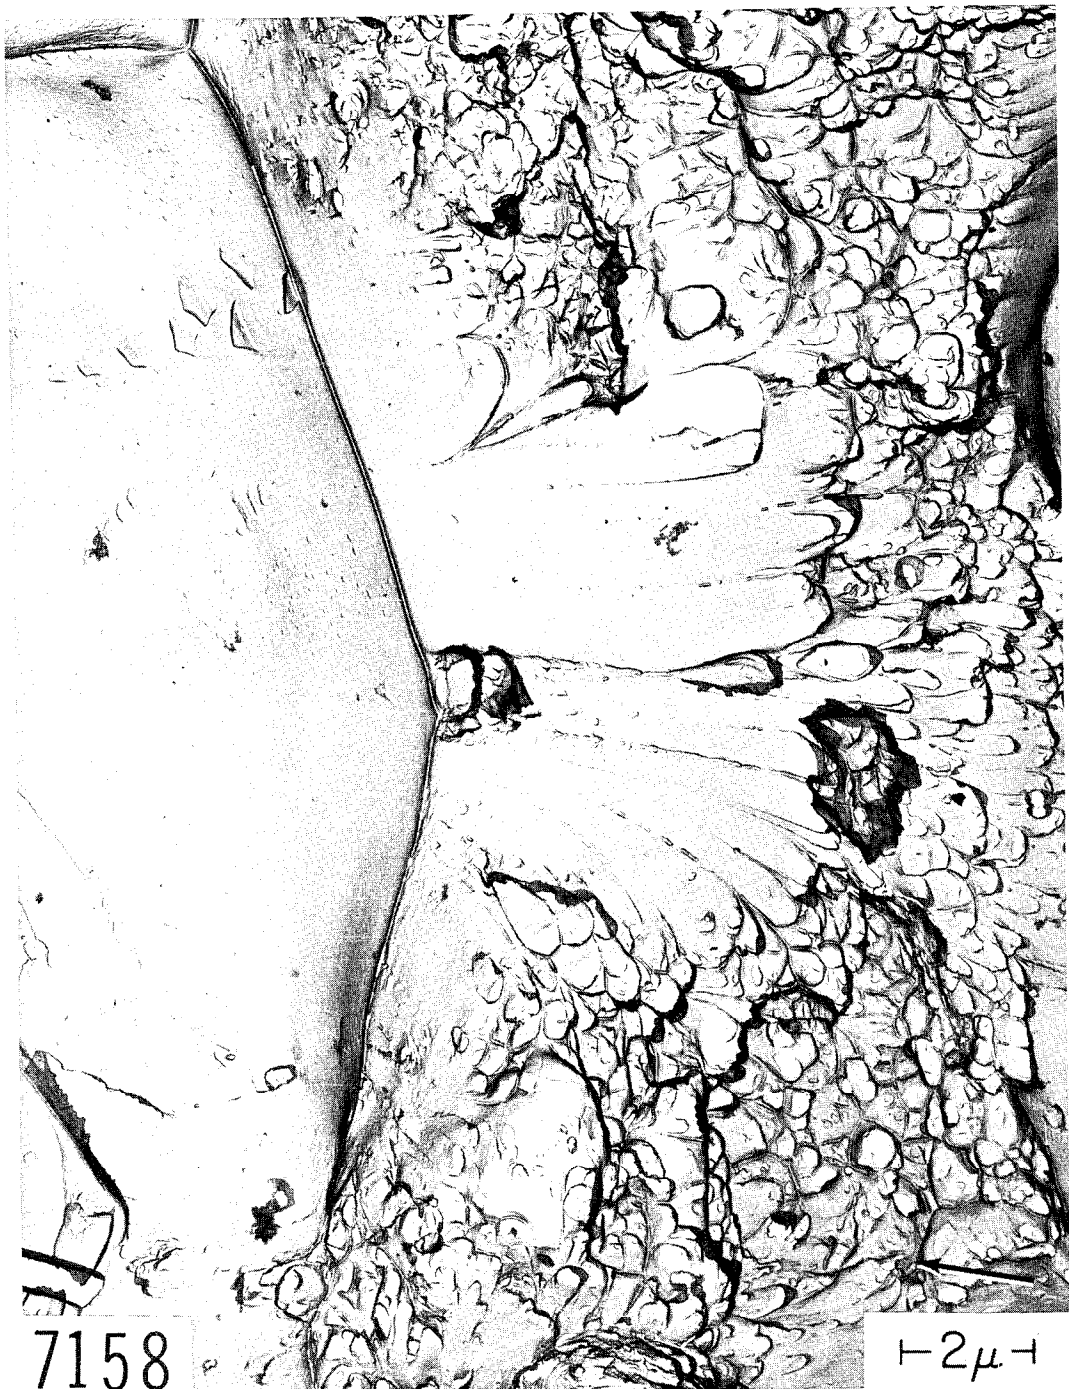
Fig. 45 - Tear dimples in plane-strain monotonic fracture surface of a 7075 T6 specimen which was broken at room temperature. Surface is matched with that shown in Fig. 44. Palladium shadowed direct carbon replica. 11,000X.

Precision matching studies showed that fracture occurred by void coalescence (Figs. 44-47), stretching (4) around broken intermetallic particles (Figs. 44-47), separation along boundaries between intermetallic particles and cleavage of intermetallic particles (Figs. 48-51), and a low deformation rupture process which is presently unidentified

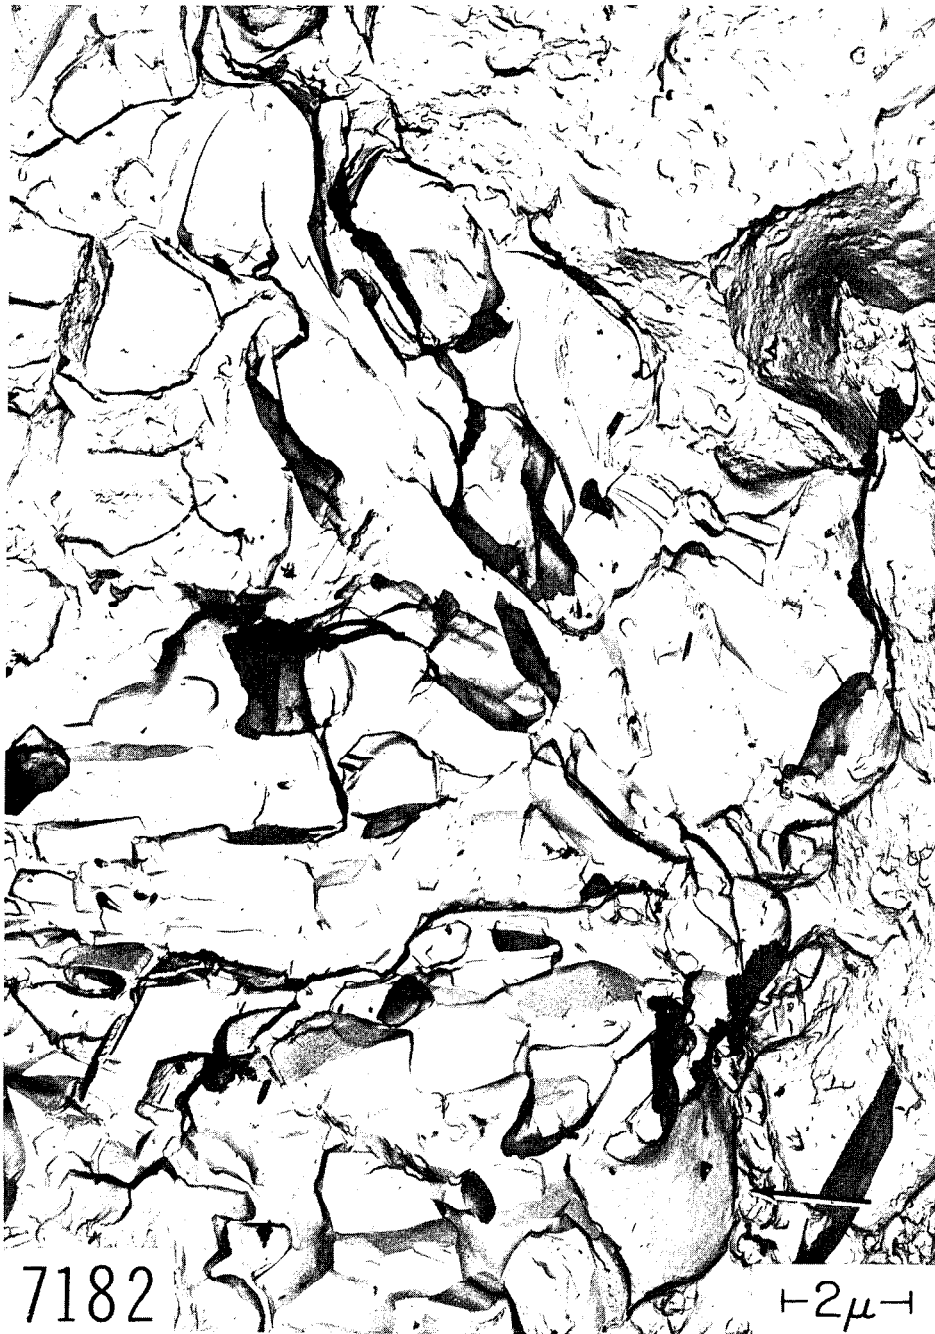
Fig. 48- Separation at intermetallic particle interface and cleavage of intermetallic particles in room temperature monotonic plane-strain fracture of 7075 T6 aluminum alloy. Matched with Fig. 49. Palladium-shadowed direct carbon replication technique. 10,500X.

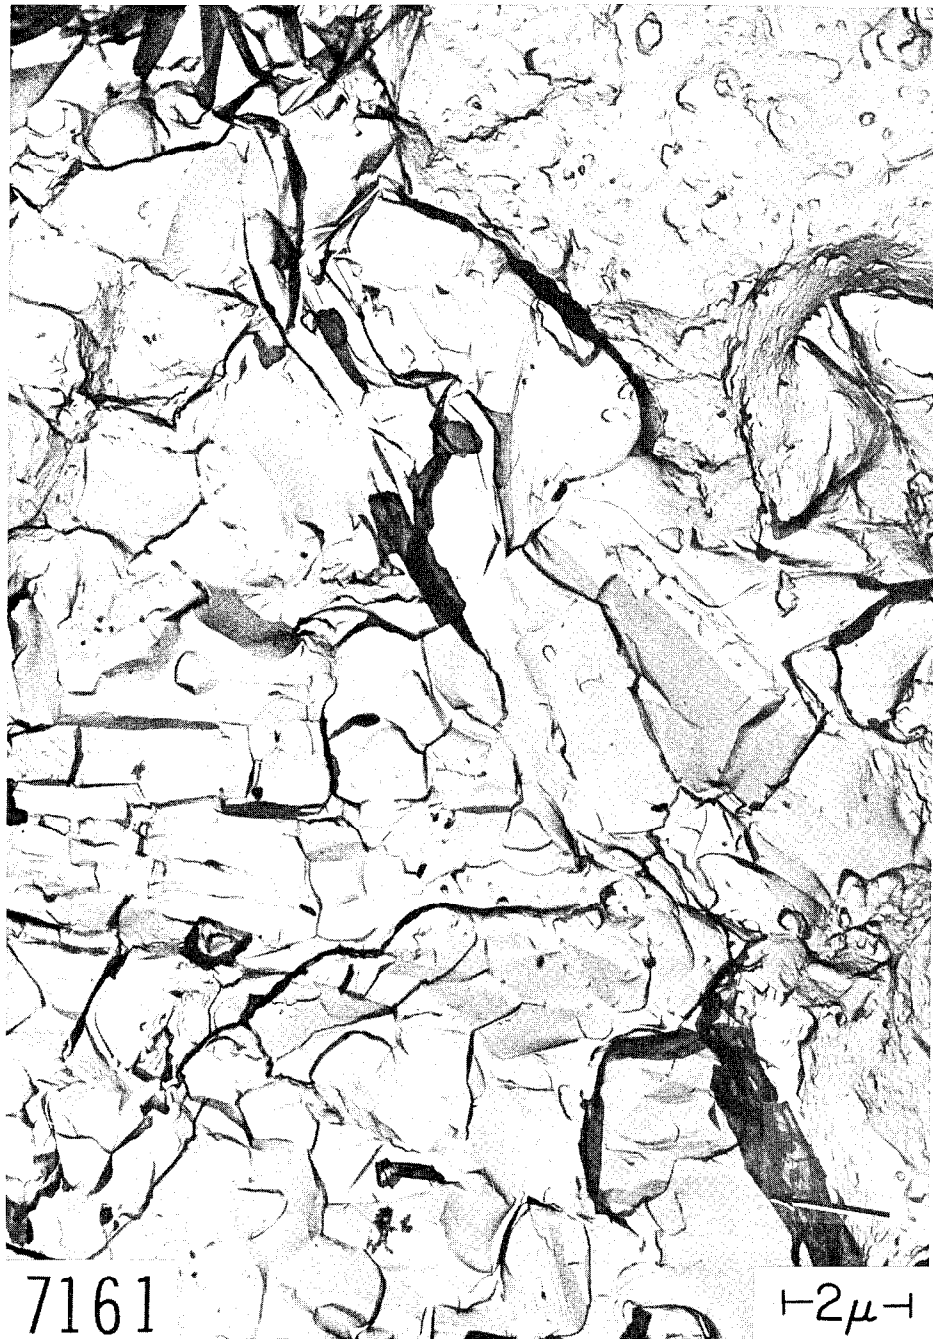
Fig. 49 - Separation at intermetallic particle interface and cleavage of intermetallic particles in room temperature monotonic plane-strain fracture of 7075 T6 aluminum alloy. Matched with Fig. 48. Palladium-shadowed direct carbon replication technique. 10,500X.

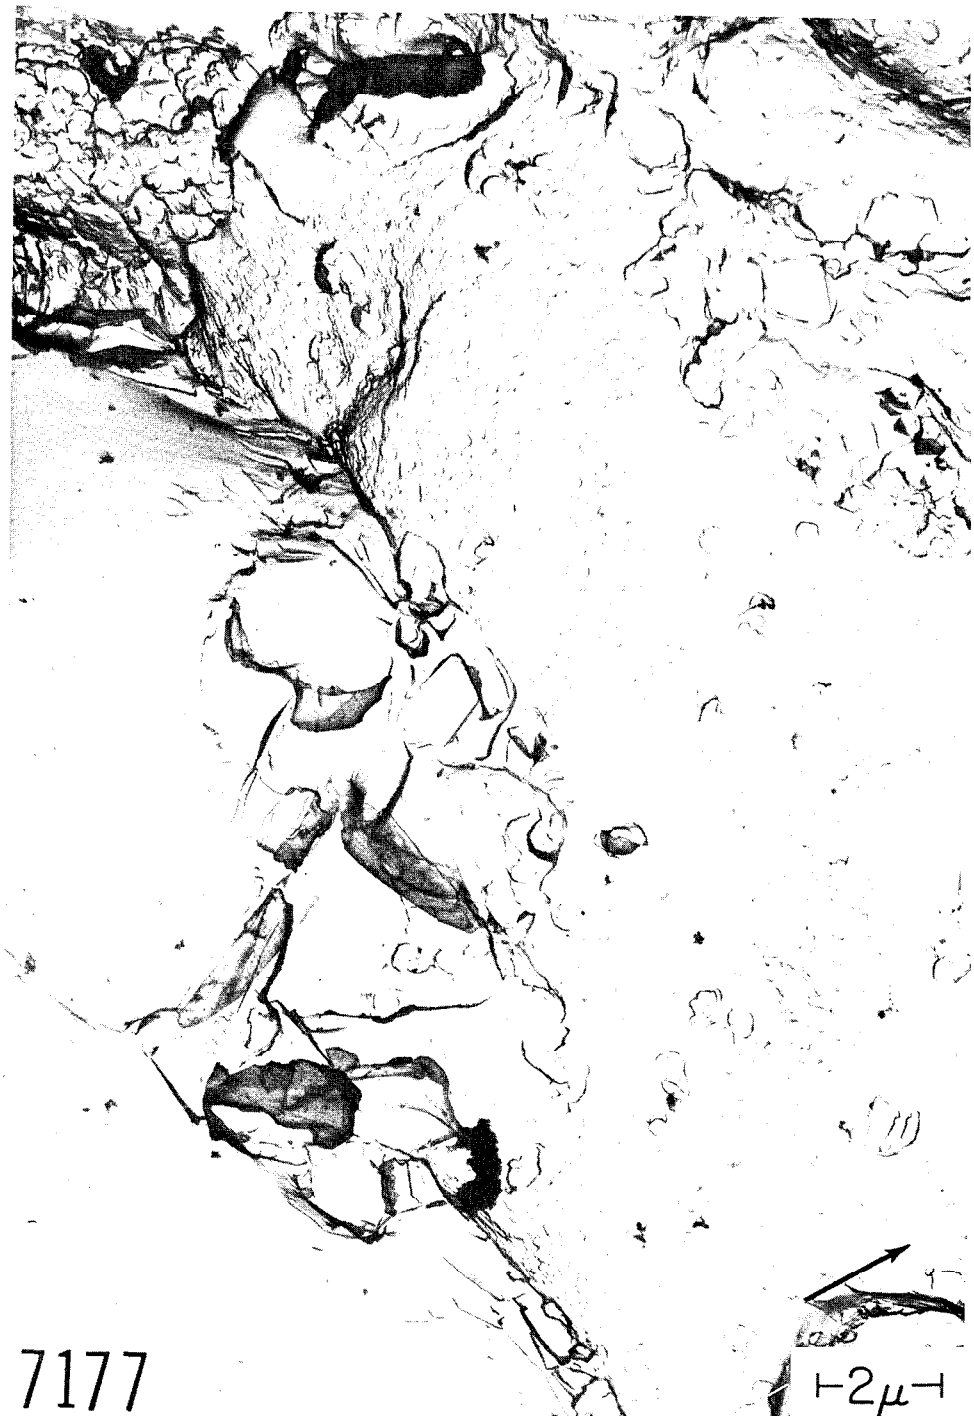
Fig. 51 - Example of a fracture surface feature in 7075 T6 aluminum alloy that is formed by unknown, but low deformation, processes. Region on the left was formed by deformation at particle-matrix interface. Matched with Fig. 50. Palladium-shadowed direct carbon replication technique. 10,500X.

(Figs. 50 and 51). Both the region bounded by arrows in Fig. 50 and its mating region on the opposite surface have been studied stereoscopically and have been seen to be concave fracture surfaces - but only slightly so. The fine detail in these regions is in general too small to be analyzed for elevation above or depression below the surrounding fracture

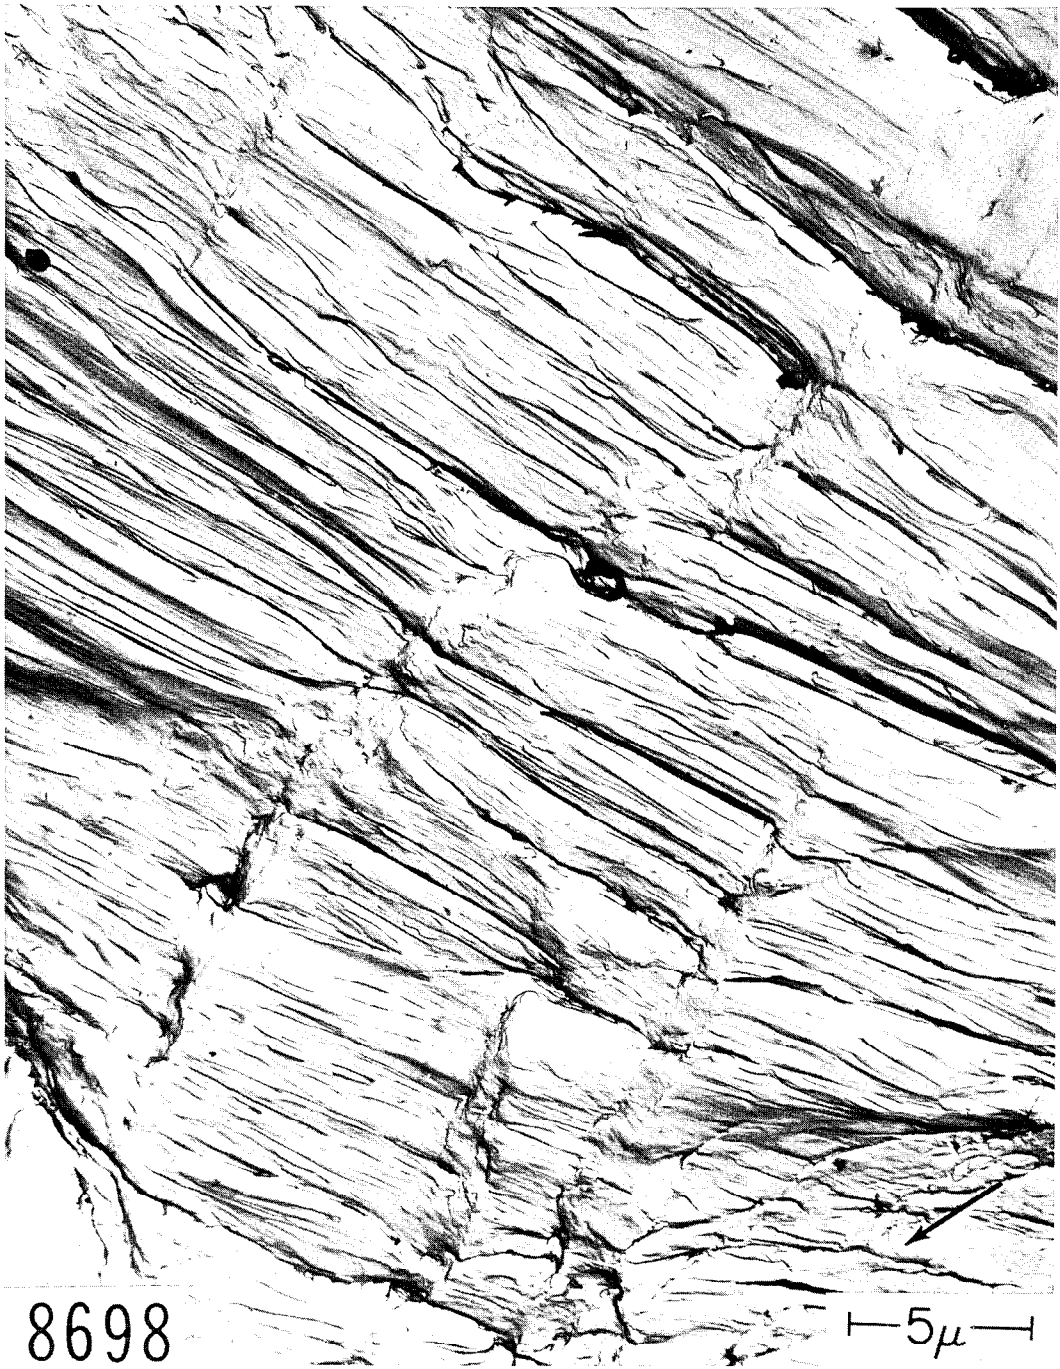
Fig. 55 - Fatigue markings in low interstitial unalloyed titanium. Cellulose acetate-carbon replication technique. Palladium shadowed. 6000X.

Figures 52 and 53 show typical features from a pure titanium fracture surface. The specimen was a Lehigh type fatigue specimen, shown in Fig. 54. Typical fatigue markings are shown in Figs. 55 and 56. Individual striations are generally straight.

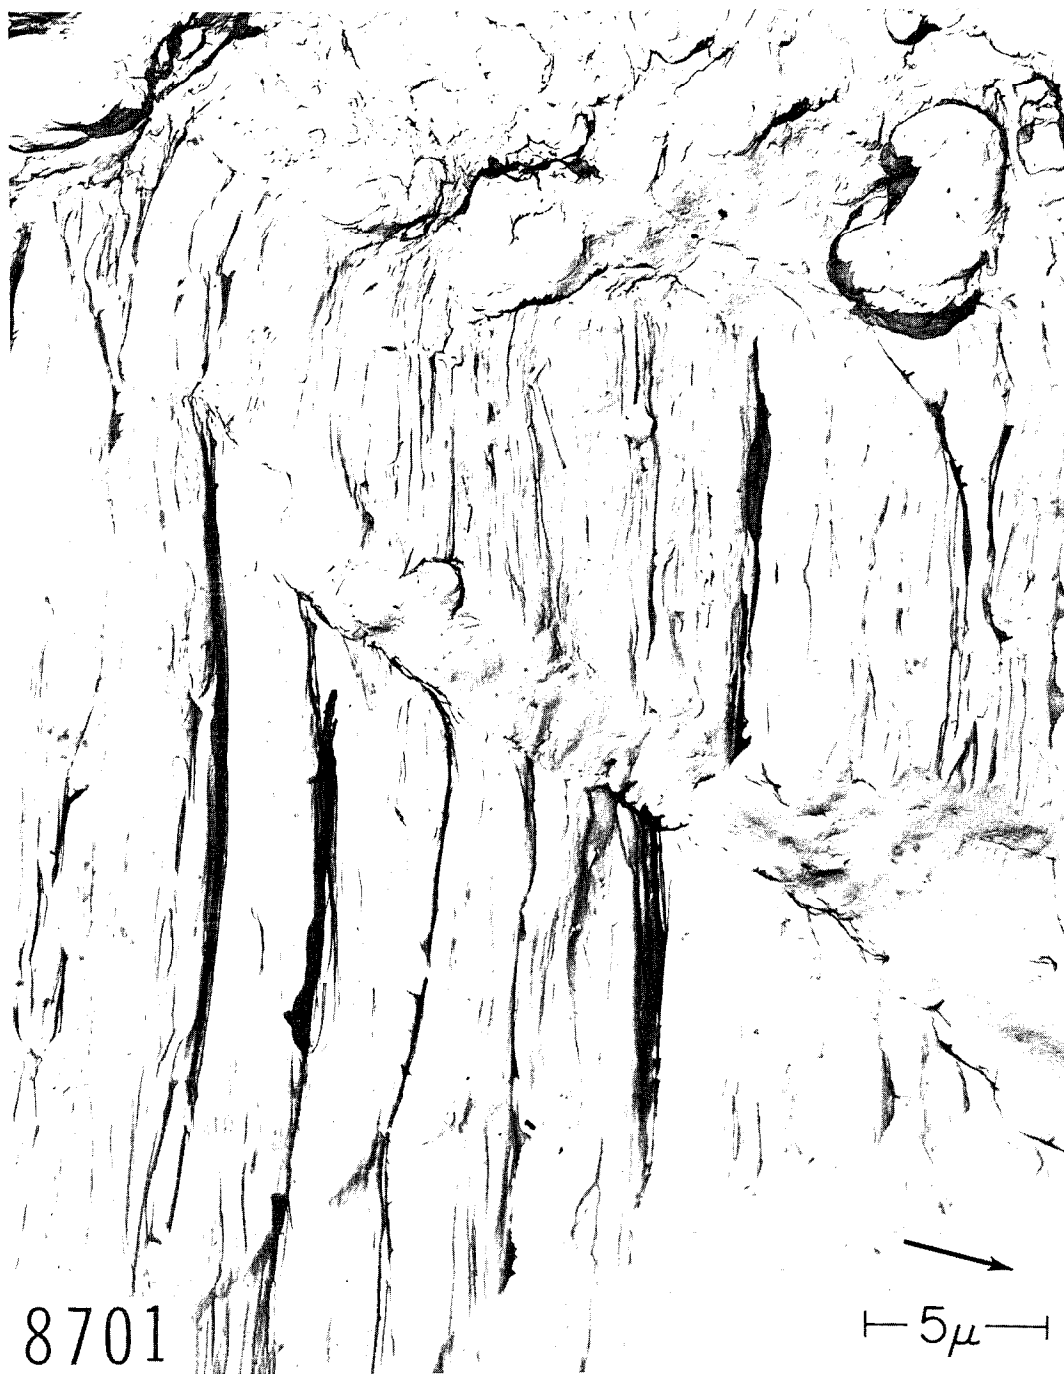
Fig. 56 - Fatigue markings in low interstitial unalloyed titanium. Cellulose acetate-carbon replication technique. Palladium shadowed. 6000X.

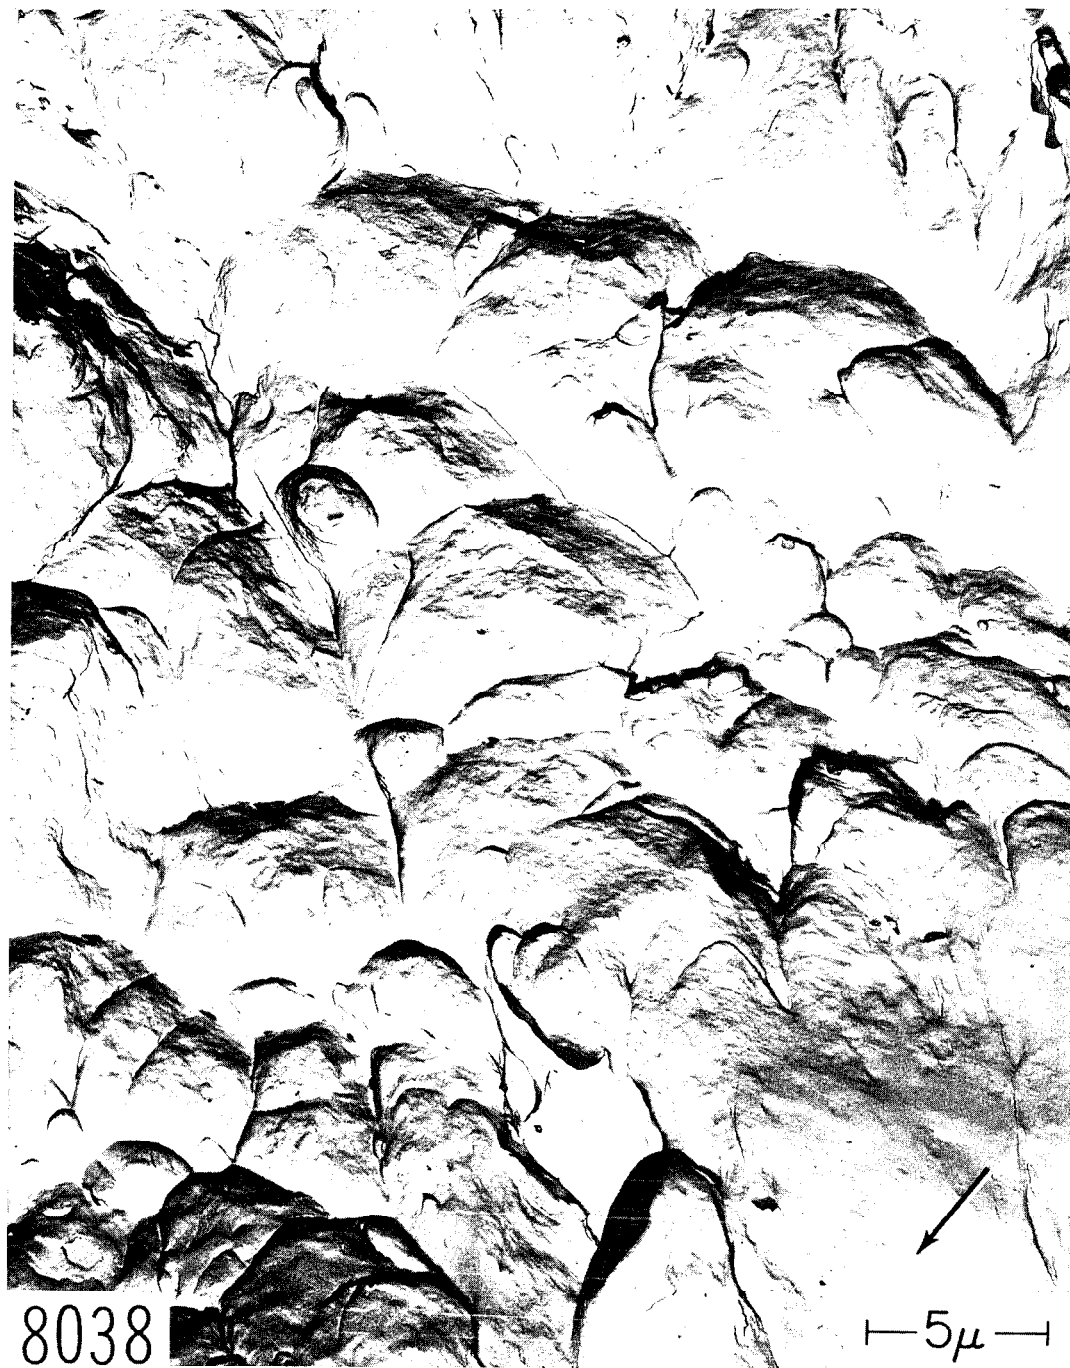
Fig. 58 - Dimpled rupture appearance of monotonic plane-strain fracture in specimen shown in Fig. 57. Cellulose acetate-carbon replication technique. Palladium shadowed. 6000X.

Figure 57 shows the macroscopic appearance of the Lehigh specimen of Ti-6Al-4V broken partially by fatigue and then broken monotonically in a tensile machine. The dimpled appearance of the overload fracture surface is seen in Fig. 58. Fatigue markings are shown in Figs. 59-61.

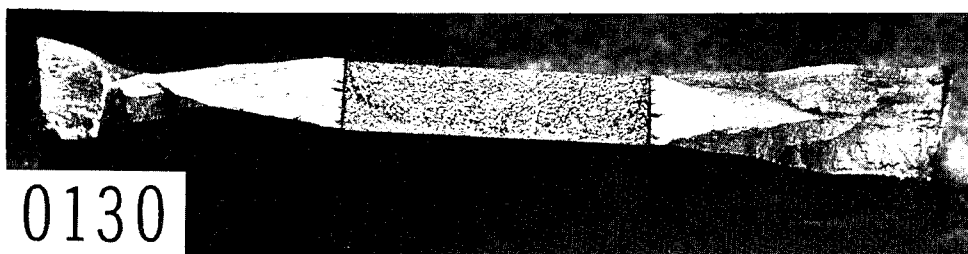
Fig. 62 - Center-cracked crack toughness specimen of Ti-6Al-4V, with an RW crack. 4X.

Figure 62 shows a 1-1/2 in. wide center-cracked sheet crack-toughness specimen of this material in the solution treated condition with an RW crack propagation direction, and Fig. 63 shows a similar specimen with a WR crack propagation direction. Characteristic fatigue markings are shown in Fig. 64 for the RW direction and Fig. 65 for the WR direction. Both specimens were tension-tension fatigued for 25,000 cycles with the load ranging from 1200 pounds to 3000 pounds. Striations are well marked in these particular fractographs, but areas without striations are common. Marked differences in elevation between patches of striations are visible when stereoscopic pairs are examined.

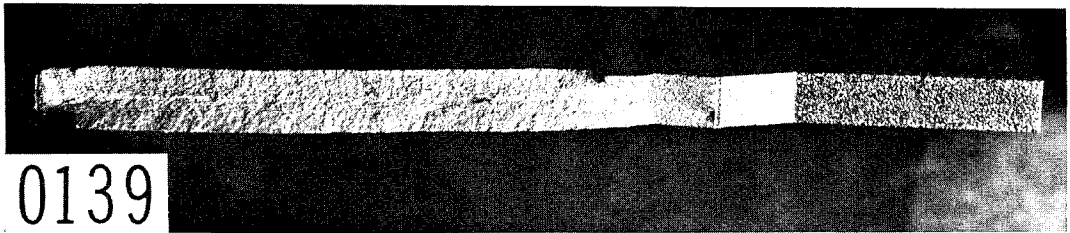
Fig. 66. Edge notched and fatigued crack toughness specimen of Ti-8Al-1Mo-1V. 6X.

Figure 66 shows a short single-edge-notched type specimen of a Ti-8Al-1Mo-1V, 0.052 in. thick and 0.981 in. wide. A K_{IC} of 45.2 KSI $\sqrt{\text{in.}}$ was calculated for this specimen. A portion of the plane strain fracture surface is seen in Fig. 67. Figures 68 and 69 show characteristic fatigue markings. Loads during the fatigue cracking were not recorded.

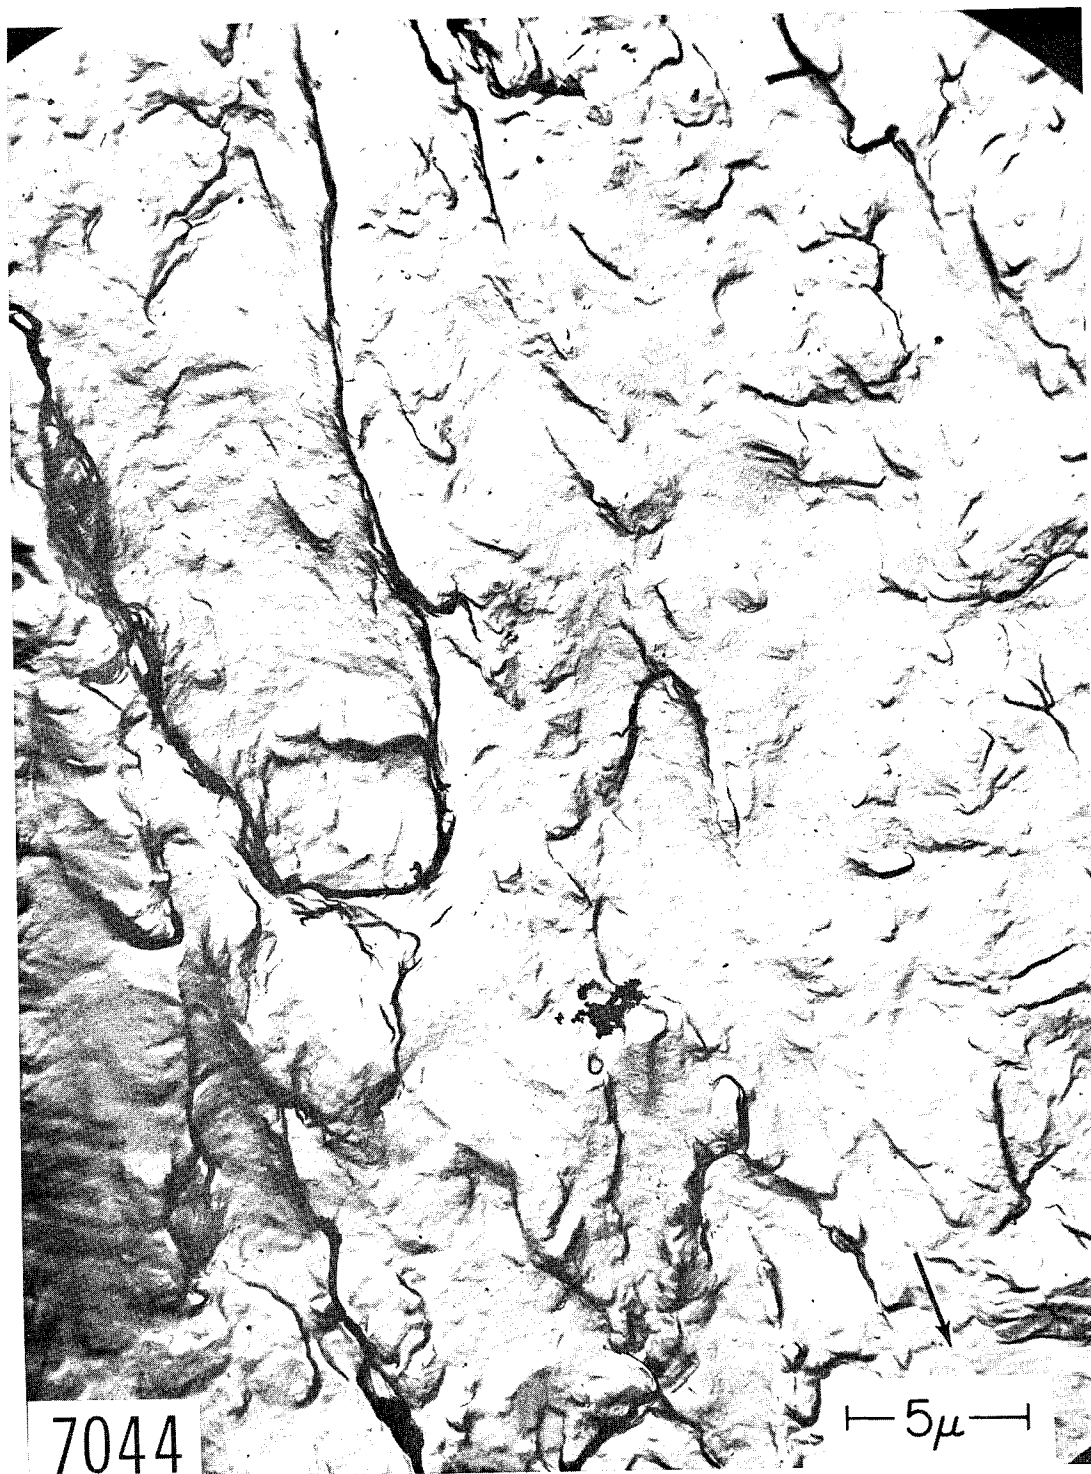
Fig. 72 - WR fatigue markings in Ti-4Al-3Mo-1V. From the specimen shown in Fig. 70. Cellulose acetate-carbon replication technique. Palladium shadowed. 6000X.

Two center-cracked sheet specimens, one with a WR crack direction and one with an RW direction are shown in Figs. 70 and 71 respectively. The WR fatigue markings are shown in Fig. 72 and the RW markings are shown in Figs. 73 and 74. The three fractographs show characteristic fracture appearances for the WR and RW modes of specimens aged 12 hours at 1150°F (R_c 33), and the RW mode of a specimen aged 12 hours at 925°F

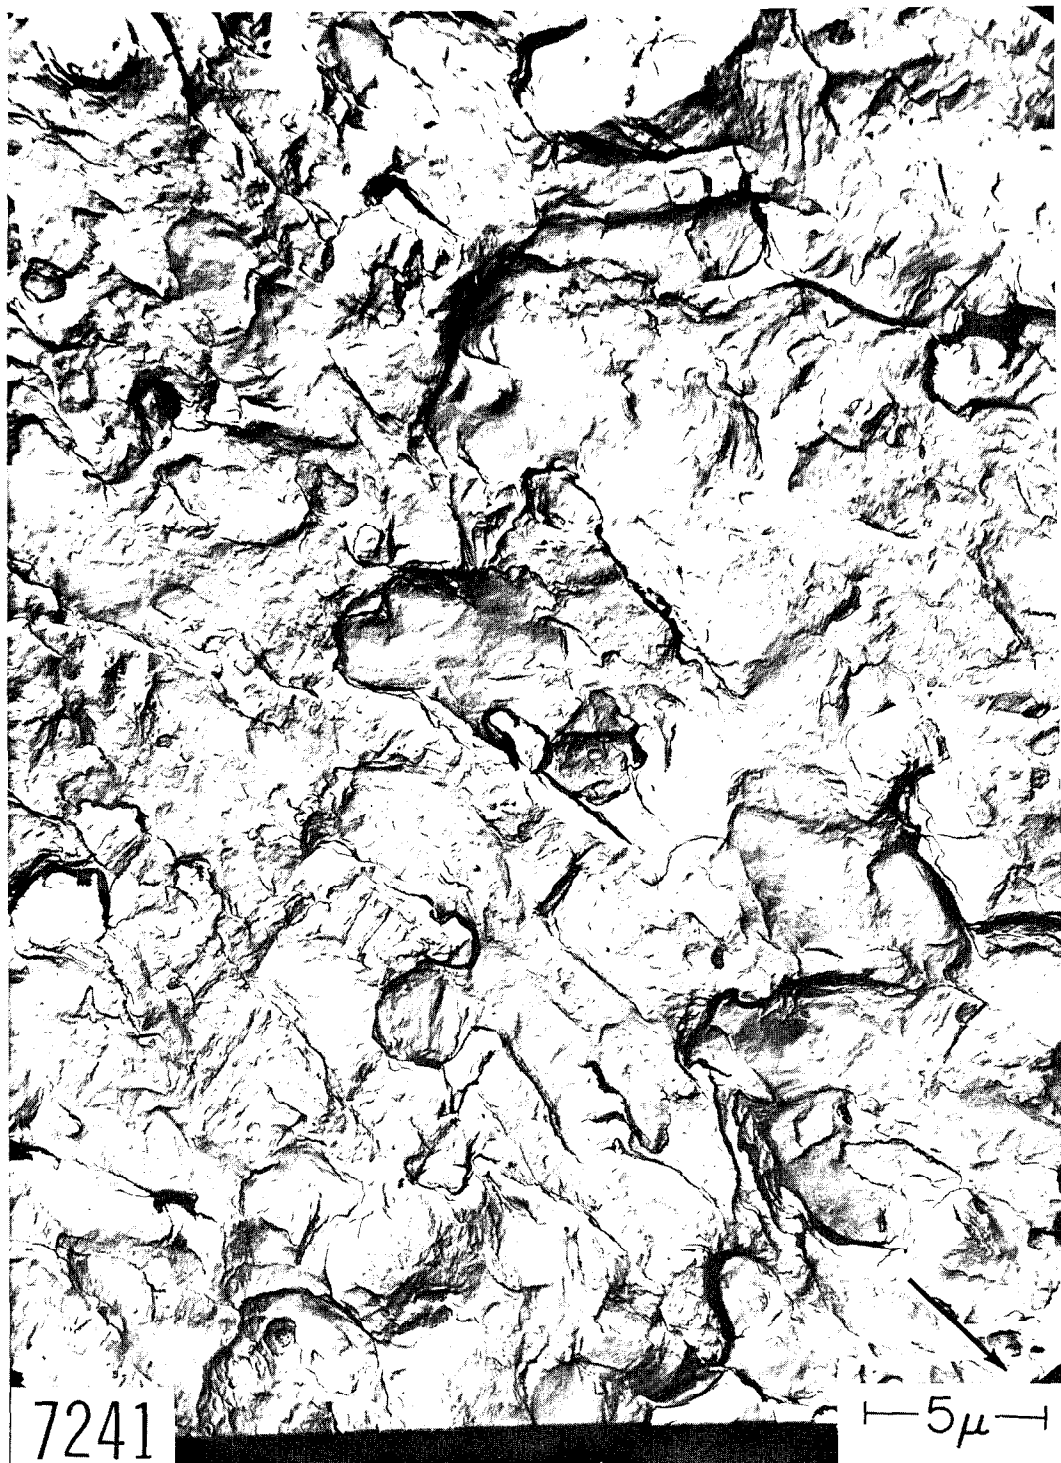
Fig. 73 - RW fatigue markings in Ti-4Al-3Mo-1V. From the specimen shown in Fig. 71. Cellulose acetate-carbon replication technique. Palladium shadowed. 6000X.

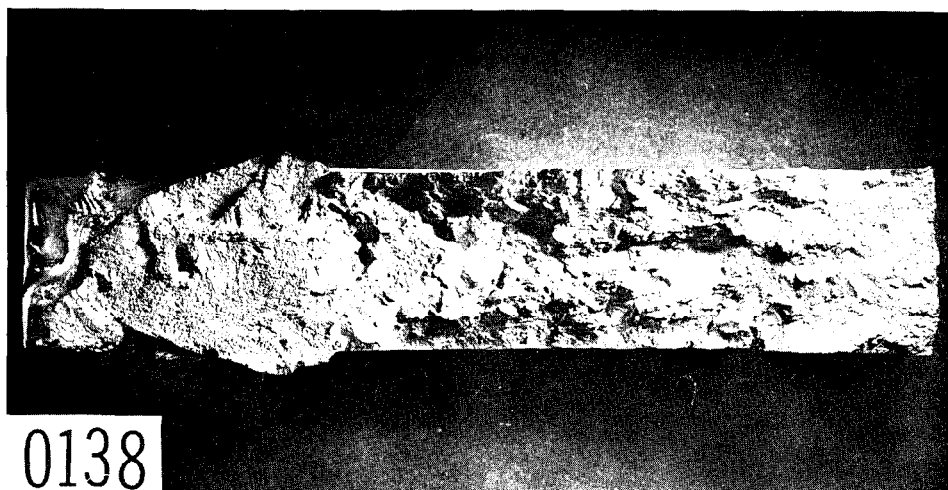
Fig. 75 - Drop weight tear specimen of as-cast
Ti-5Al-3Sn-2Mo-2V alloy. 1-1/2X.

Figure 75 shows the fracture surface of a drop weight tear test specimen* of an as-cast piece of Ti-5Al-3Sn-2Mo-2V alloy. The intergranular nature of the part of the fracture is apparent. Figure 76 shows dimples on one facet of one of the grain surfaces. Figures 77-80 show dimples and other features seen on transgranular portions of the fracture. Figure 80 shows long shallow trough-like dimples associated with angular constituent particles (arrows).

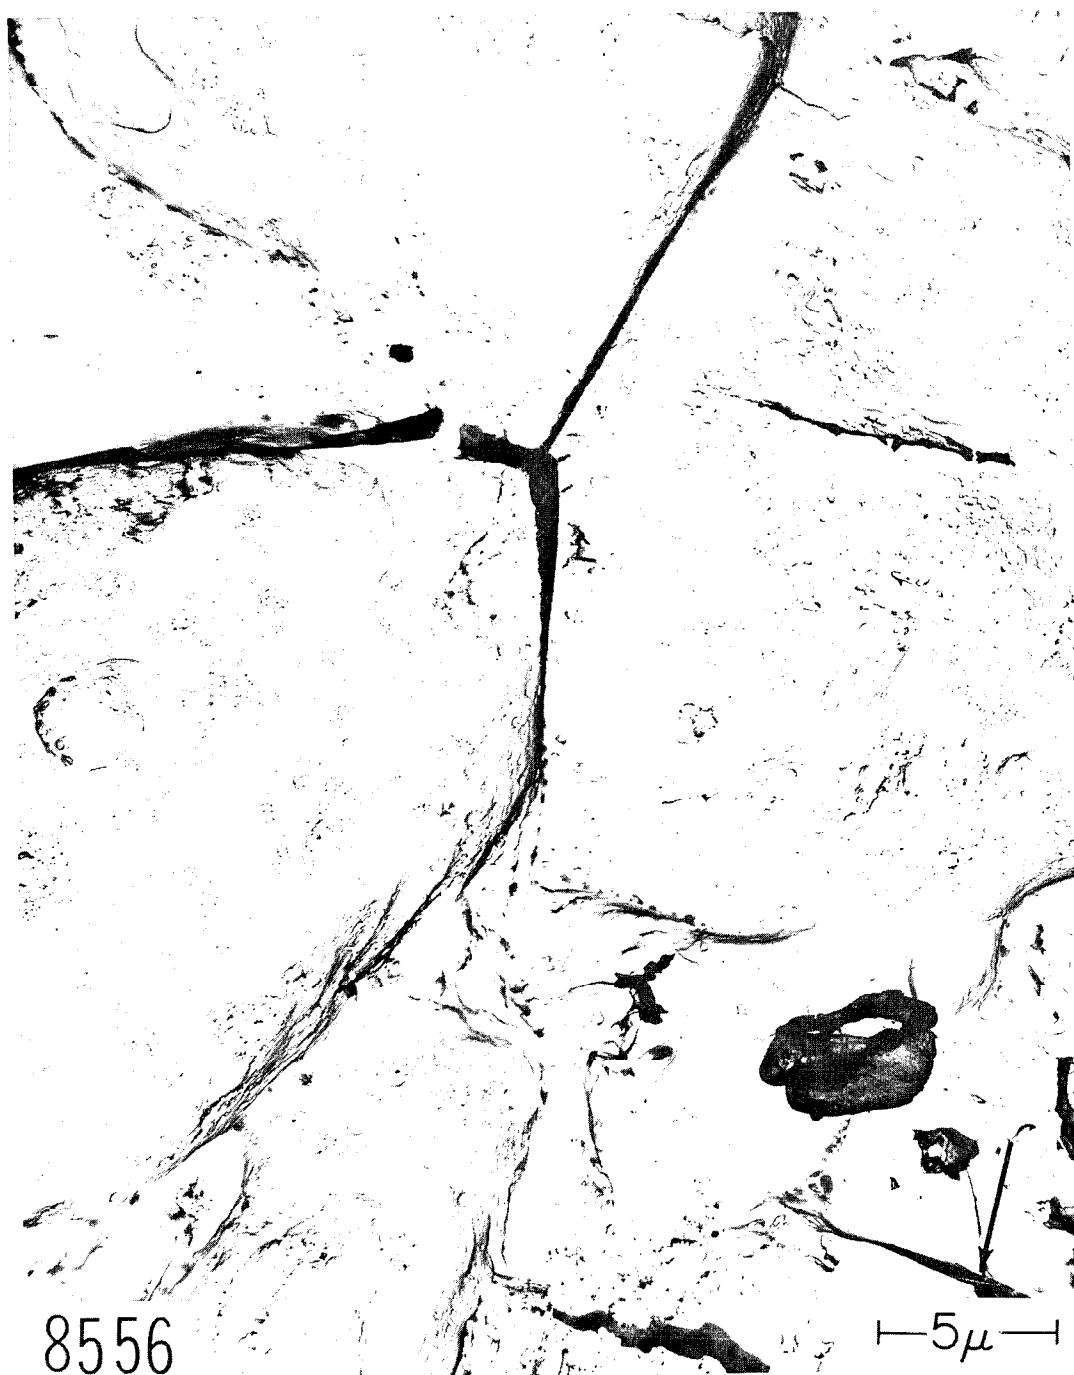
Fig. 77 - Transgranular monotonic impact fracture surface of as cast Ti-5Al-3Sn-2Mo-2V specimen shown in Fig. 75. Cellulose acetate-carbon replication technique. Palladium shadowed. 6000X.

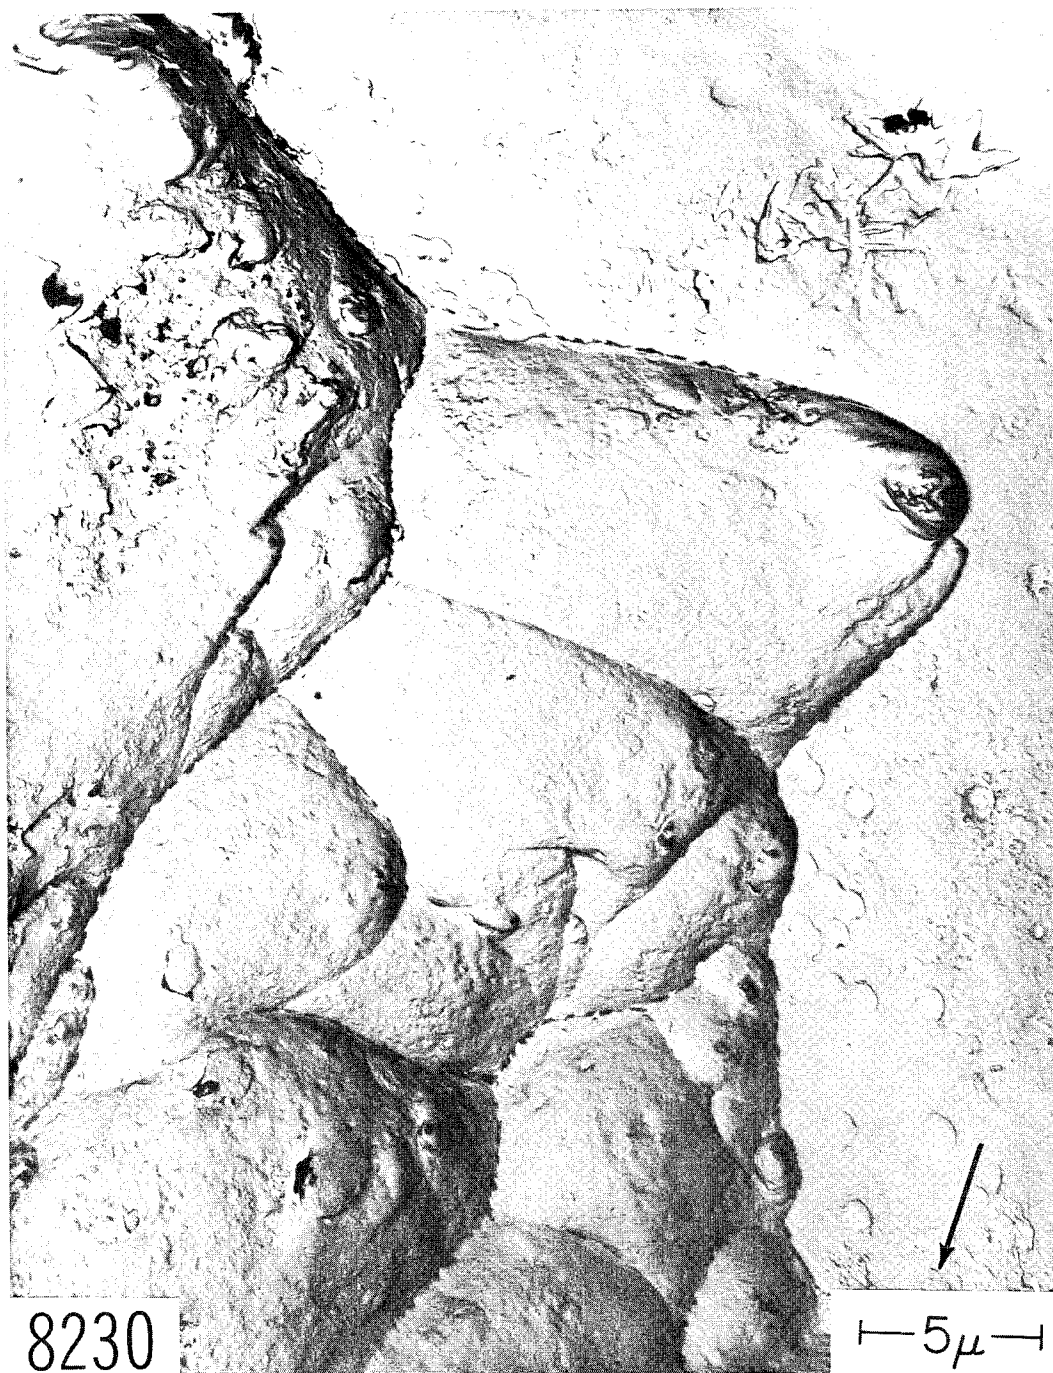
Fig. 78 - Transgranular monotonic impact fracture surface of as cast Ti-5Al-3Sn-2Mo-2V specimen shown in Fig. 75. Cellulose acetate-carbon replication technique. Palladium shadowed. 6000X.

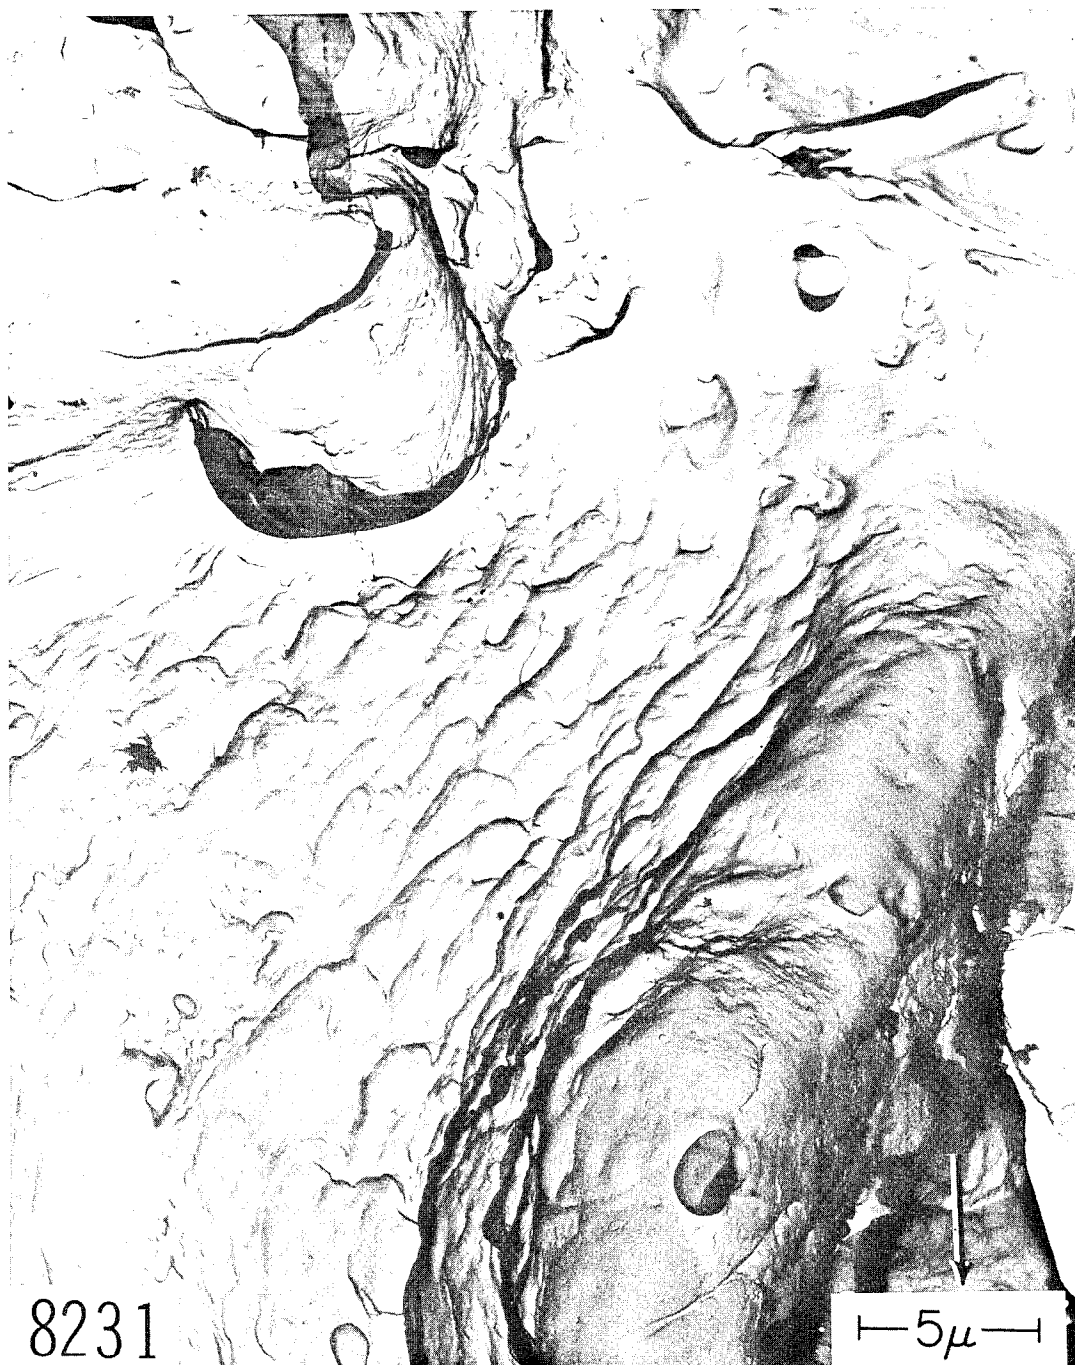
Fig. 79 - Transgranular monotonic impact fracture surface of as cast Ti-5Al-3Sn-2Mo-2V specimen shown in Fig. 75. Cellulose acetate-carbon replication technique. Palladium shadowed. 6000X.

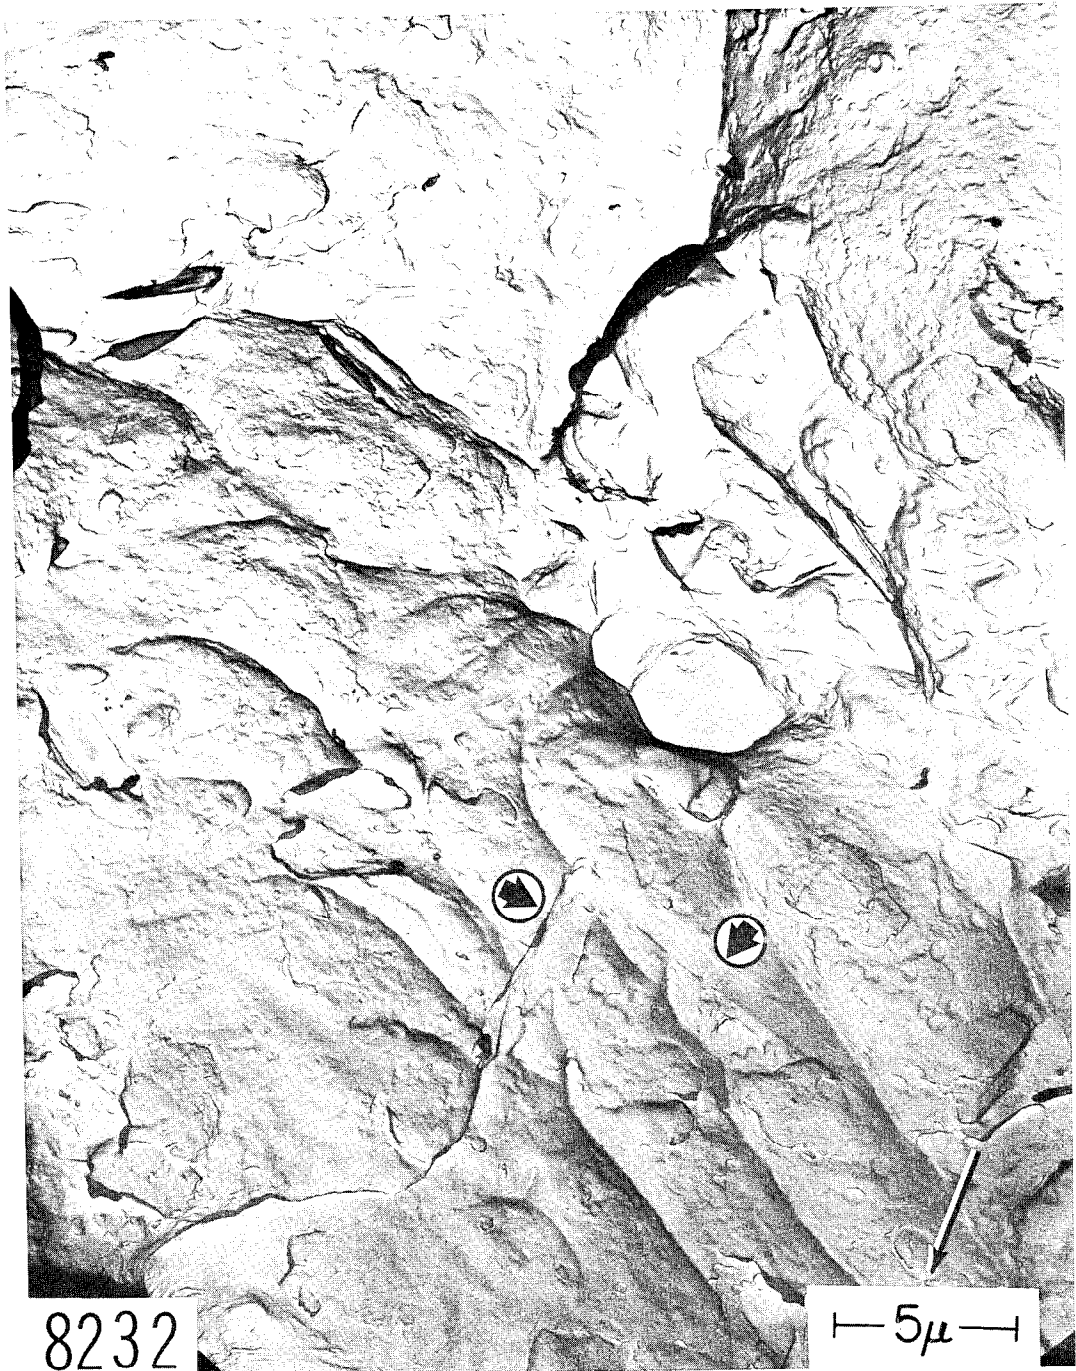
Fig. 80 - Transgranular monotonic impact fracture surface of as cast Ti-5Al-3Sn-2Mo-2V specimen shown in Fig. 75. Cellulose acetate-carbon replication technique. Palladium shadowed. 6000X.
